DEPARTMENT OF TRANSPORTATION

Quality Assurance and Source Inspection

Contract #: 04-0120F4Cty: SF/ALA Rte: 80 PM: 13.2/13.9File #: 69.28**WELDING INSPECTION REPORT****Resident Engineer:**Siegenthaler, Peter**Address:** 333 Burma Road**City:** Oakland, CA 94607**Report No:** WIR-018946**Date Inspected:** 01-Dec-2010**Project Name:** SAS Superstructure**OSM Arrival Time:** 700**Prime Contractor:** American Bridge/Fluor Enterprises, a JV**OSM Departure Time:** 1900**Contractor:** Zhenhua Port Machinery Company, Ltd (ZPMC), Changxing Island **Location:** Shanghai, China**CWI Name:** Xu Le Feng**CWI Present:** Yes No**Inspected CWI report:** Yes No N/A**Rod Oven in Use:** Yes No N/A**Electrode to specification:** Yes No N/A**Weld Procedures Followed:** Yes No N/A**Qualified Welders:** Yes No N/A**Verified Joint Fit-up:** Yes No N/A**Approved Drawings:** Yes No N/A**Approved WPS:** Yes No N/A**Delayed / Cancelled:** Yes No N/A**Bridge No:** 34-0006**Component:** TOWER & OBG Components**Summary of Items Observed:**

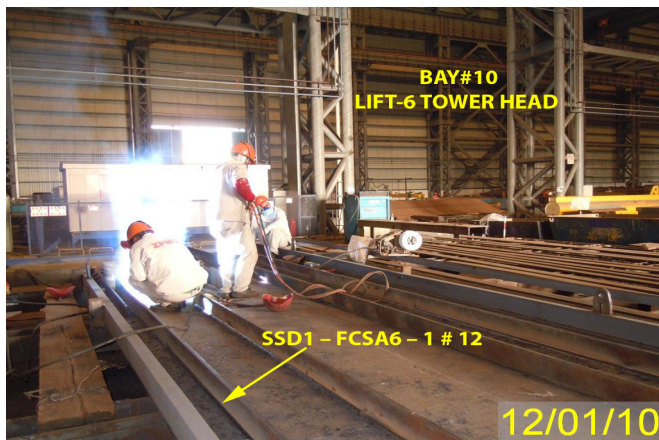
Weld joint # 12 located on Lift-6 tower head component SSD1 – FCSA6 – 1. Welder is identified as 040302. ZPMC Quality Control (QC) Inspector is identified as Li Peng Fei. The welding variables recorded by QC appeared to comply with the WPS – B – T – 2132. (See the attached photo)
